Evaluation Report 19

McKee Model 1500 Round Baler

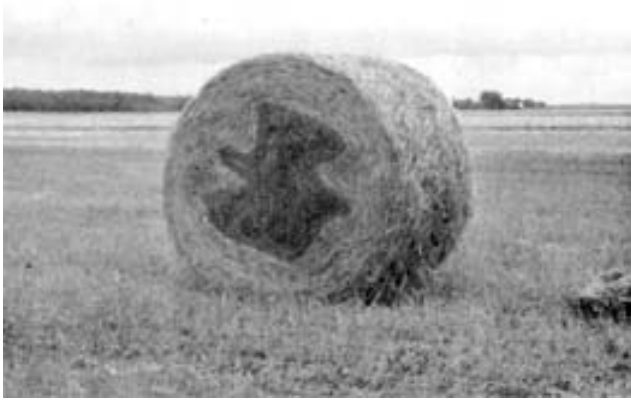
Figure 4. Typical Bales Formed by the McKee 1500.

Bale Quality: The McKee 1500 produced fairly firm, durable bales (Figure 4) with flat ends and uniform diameter. Bales averaged 1.5 m (59 in) in length and 2 m (78 in) in diameter. Average hay bales weighed from 760 to 840 kg (1680 to 1850 lb) with an average density of 173 kg/m³ (10.8 lb/ft³). Density at the outer diameter was about double that at the centre of the bale.

Due to the low density bale core, bales settled somewhat and flattened during storage. As a result, these bales were slightly more difficult to pick, with some bale handlers, than higher density bales.

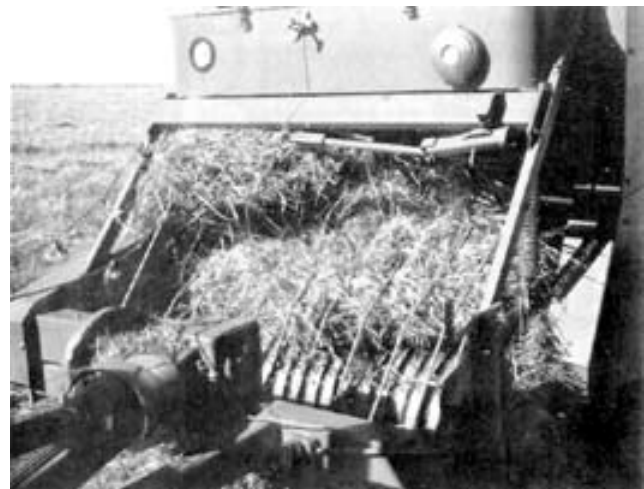
Figure 7. Plugging in Heavy Windrows Due to Excessive Lift of Compression Bars.

Feeding: Feeding was positive and aggressive in nearly all crops with only infrequent plugging. In very heavy windrows, wads of hay occasionally caused the floating pickup compression bars to raise higher than the top of the bale chamber opening. If this happened, hay fed up the front of the forming belts rather than into the bale chamber (Figure 7). Two minor modifications greatly reduced this problem: The allowable upward movement of the pickup compression bars was reduced and the compression bar limiting arm was strengthened. Extending the pickup compression bars to minimize the distance between the compression bars and the bale chamber opening is also recommended to improve feeding.

The pickup compression bar pivot point was adjustable with the option of two positions. With minor alterations during the test, the compression bar flotation limit was also made adjustable. Limiting the maximum lift of the compression bars improved feeding in heavy windrows.
